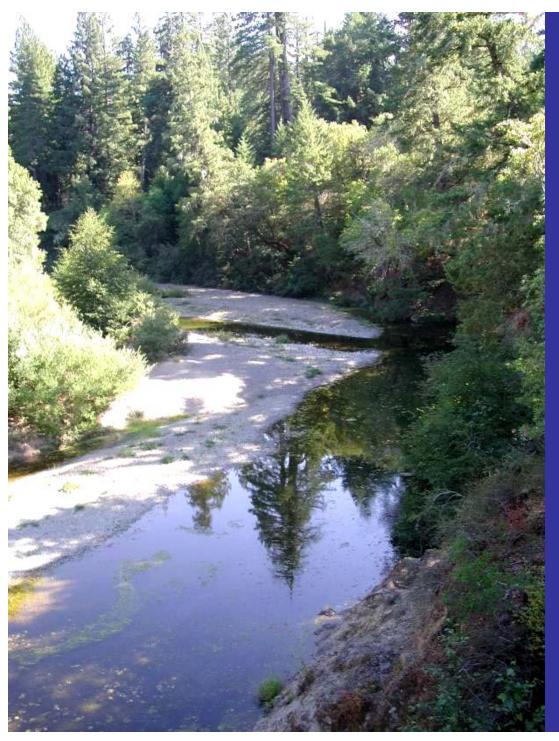
Photo from KRIS Navarro. September 21, 2001.

Navarro River at Hendy
Woods State Redwood Park
is so flow depleted that only a
stagnant pool not suitable for
human contact remains. The
mainstem Navarro was
formerly rearing habitat for
juvenile steelhead and a
major recreational draw
during the hot days of
summer and fall.

CA Water Code § 1243 is clearly not being upheld in this basin.

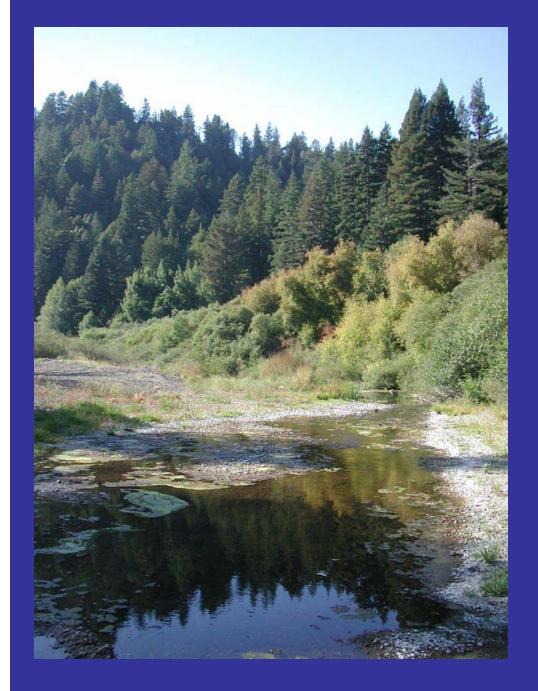
The lower mainstem Navarro River near Flume Gulch is shown at left during low flow conditions on September 21, 2001. The USGS flow gauge indicated that the average flow on this day was 1.1 cubic feet per second. The algae on the margins of the stream indicate stagnation and no fish were present at the time of observation. The California Department of Fish and Game sampled this exact location in August 12, 1952 and found steelhead trout of varying sizes and a flow of 15 cfs during what was an average water year. Photo from KRIS Navarro by Pat Higgins.

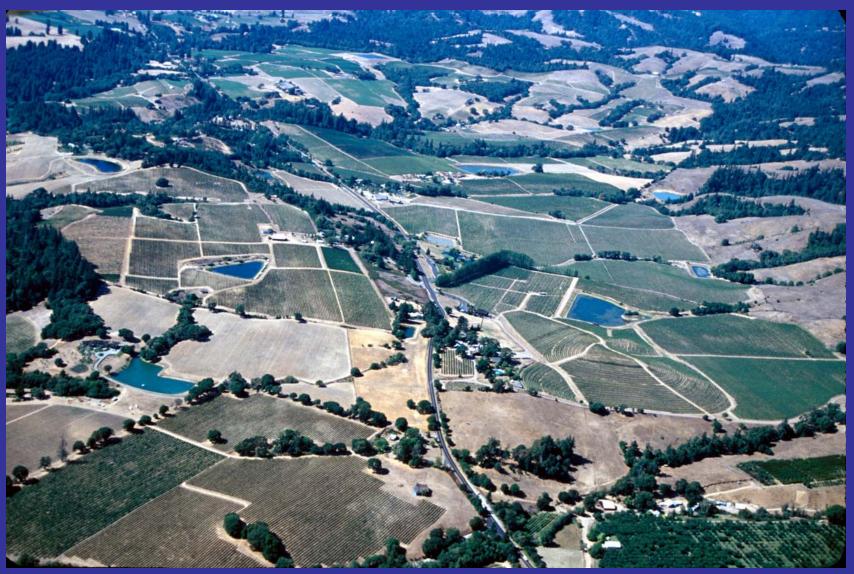
Aerial photo of agricultural development in the Navarro River basin circa 1998 shows ten irrigation ponds of different types and expanding vineyards that have caused almost complete loss of public trust river resources.

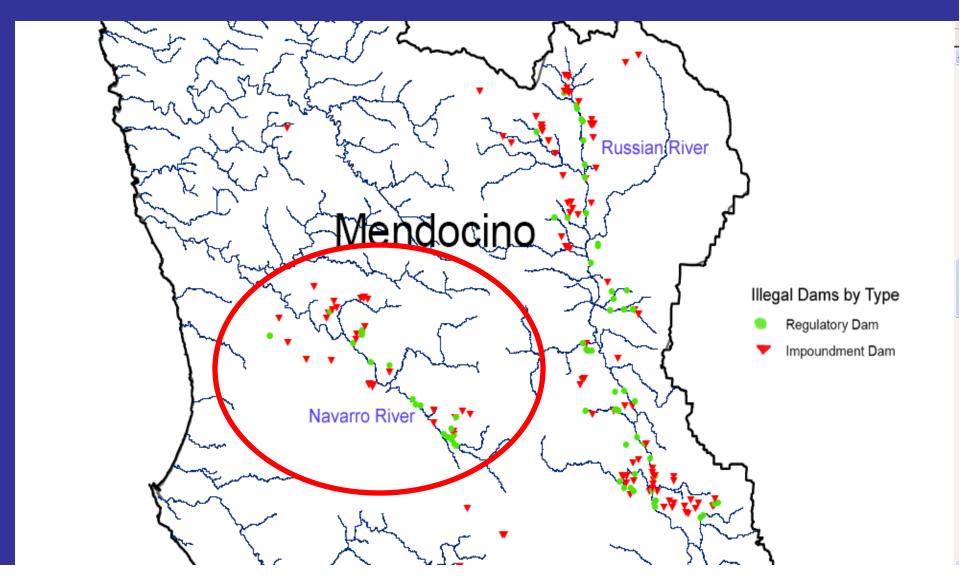
Navarro River map area highlighted by red circle shows the number of agricultural impoundments and dams on tributaries. Many of these structures were built without permits yet the State Water Resources Control Board has not required any to be removed.
