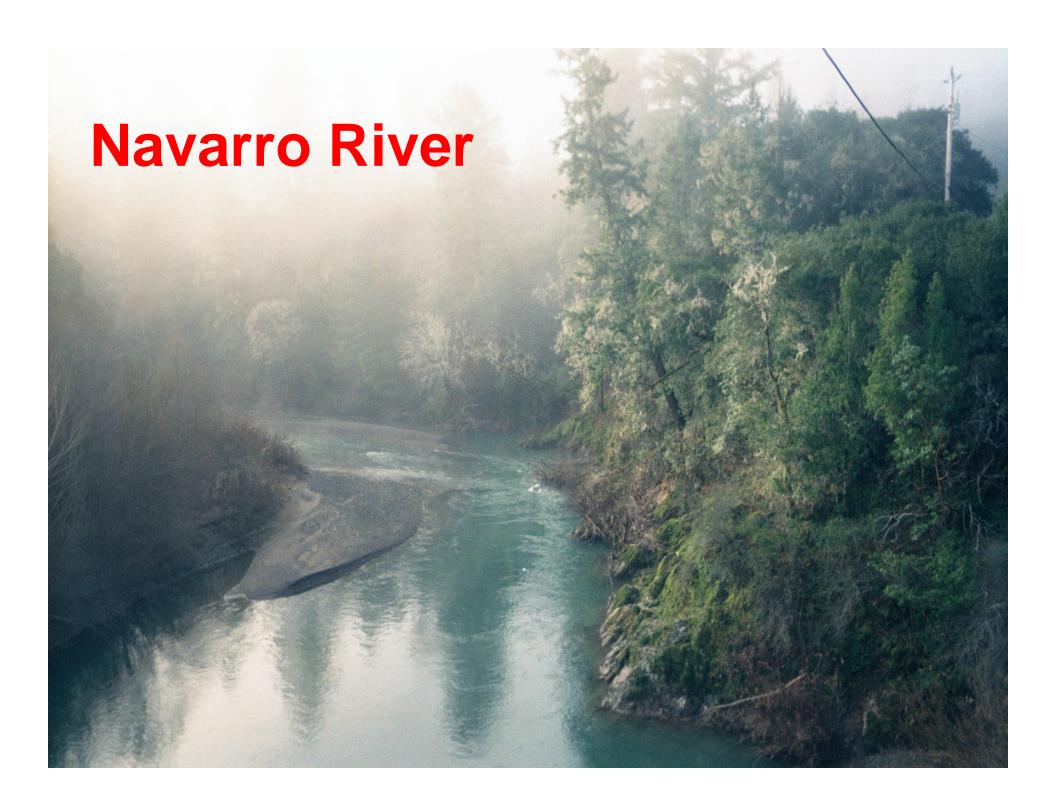
Navarro River at Hendy
Woods State Redwood Park
is so flow depleted that only a
stagnant pool not suitable for
human contact remains. The
mainstem Navarro was
formerly rearing habitat for
juvenile steelhead and a
major recreational draw
during the hot days of
summer and fall.

CA Water Code § 1243 is clearly not being upheld in this basin.

Photo from KRIS Navarro. September 21, 2001.
